Preparation of JetStar Wing for Use in Deicing Research

APS AVIATION INC. APS

August 2000

Final Version 1.0

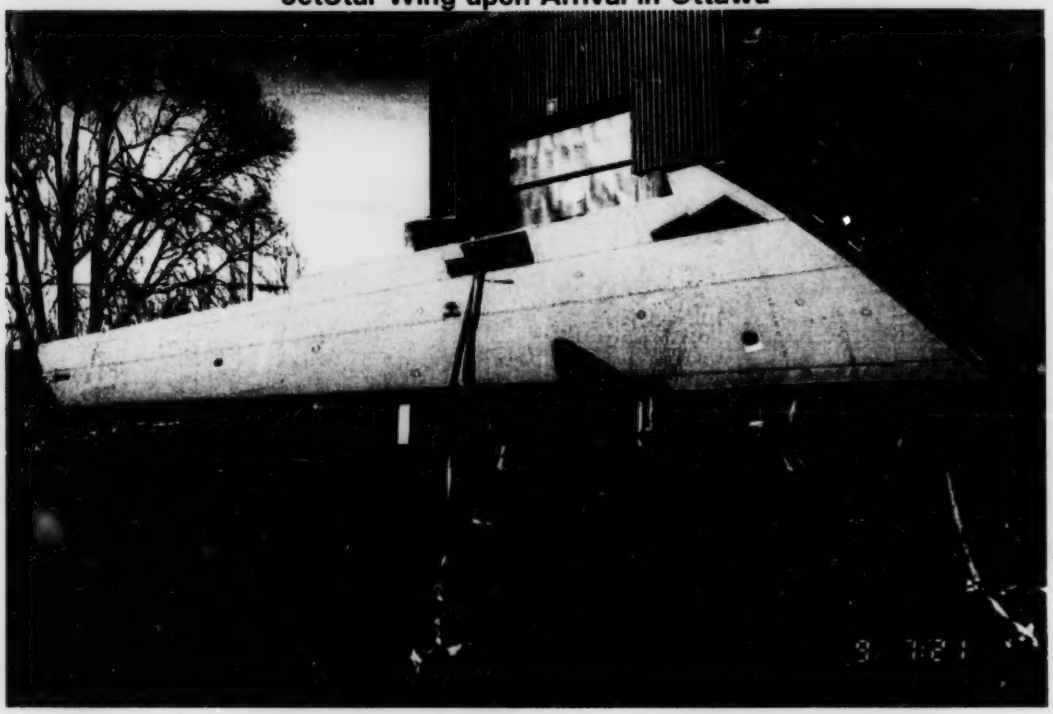
Photo 2.3
JetStar Wing upon Arrival in Ottawa

Two small panels on the main wing section were missing when the aircraft was delivered to APS in April 1999 (see Photo 2.3). In addition, the external fuel tank (see aircraft three-view drawing in Figure 2.1) was removed by the salvage company prior to delivery of the wing, requiring the fabrication of a fairing to fill the large hole in the leading edge where the tank was located and to restore the original wing profile. The fairing and missing panels were constructed of galvanized metal and painted.

Two small panels on the main wing section were missing when the aircraft was delivered to APS. In addition, the external fuel tank was removed by the salvage company prior to delivery of the wing, so a fairing was required to fill the large hole in the leading edge where the tank had been and to restore the original wing profile. The fairing and missing panels were constructed of galvanized metal and painted. To prevent rust formation and to ensure consistency with the other wing sections, it is recommended that:

- The galvanized metal panels and fairing be replaced with aluminum.

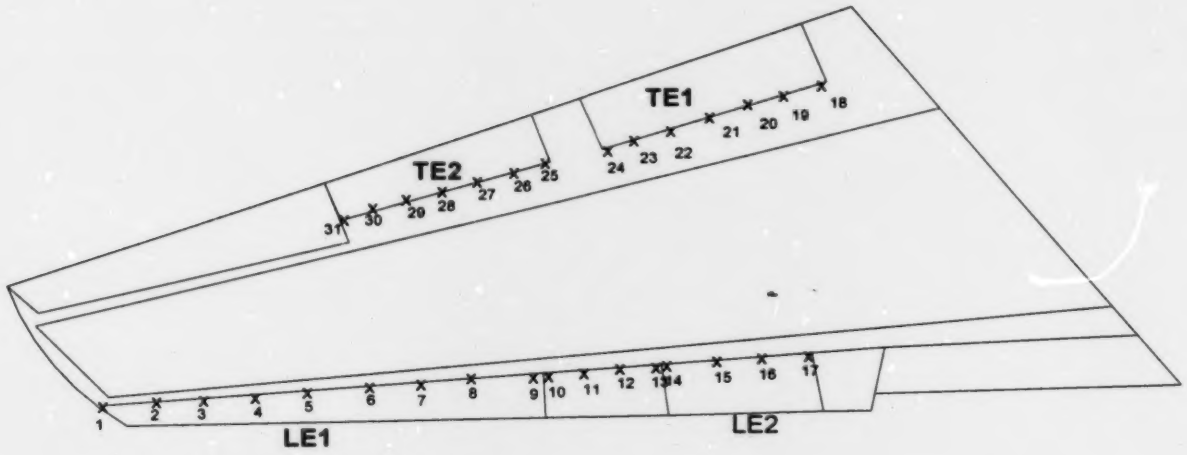
Figure 3.3

Hard Wing/Flight Surface Wing Gaps

Measurements taken at 28 cm intervals.

LE1	
Loc	Gap (mm)
1	1.75
2	2.24
3	1.75
4	1.75
5	2.29
6	1.19
7	1.75
8	0.61
9	1.19
10	1.75
11	1.75
12	1.75
13	0.61

TE1	
Loc	Gap (mm)
25	1.75
26	< 0.38
27	< 0.38
28	0.89
29	0.61
30	< 0.38
31	< 0.38
